STRESS CORROSION CRACKING OF TITANIUM ALLOYS

PROGRESS REPORT: JANUARY 1-MARCH 31, 1965

S. P. Rideout, M. R. Louthan, Jr., and C. L. Selby

*Savannah River Laboratory**Aiken, South Carolina*

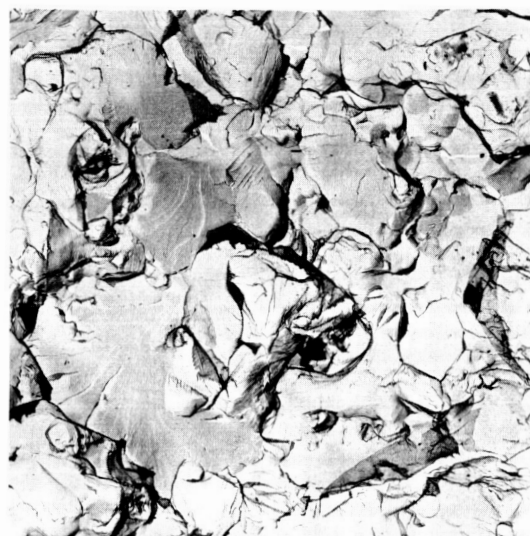
a. Cracks produced by HCl exposures.

b. Cracks produced by NaCl exposures.

FIG. 2 FRACTOGRAPHIC COMPARISON OF CRACKS DEVELOPED IN Ti-8Al-1Mo-1V ALLOY EXPOSED AT 650°F TO ANHYDROUS HCl AND TO NaCl. The surface of the specimen cracked with HCl is clean and shows evidence of cleavage fracture, whereas extensive corrosion is apparent on the surfaces of the cracks induced by NaCl.

The fracture surfaces of cracks produced at 650°F by exposure to HCl gas and to NaCl are compared in Figure 2. The surface of the fracture produced by HCl shows characteristic patterns of mechanical cleavage, whereas corrosion is evident in the NaCl cracks. The latter observation does not preclude the possibility that the corrosion occurred after the cracks had been formed by mechanical rupture of metal embrittled by corrosion-produced hydrogen.
